LPC# 1210500002 Marion County
Sandoval Zinc Co. - Sandoval
ILD 053 980 454
F/HRS

Expanded Site Inspection

Sandoval Zinc Company
Box 263 Smelter Road Highway 51, Sandoval, Illinois
ILD 053 980 454

April 5, 2010

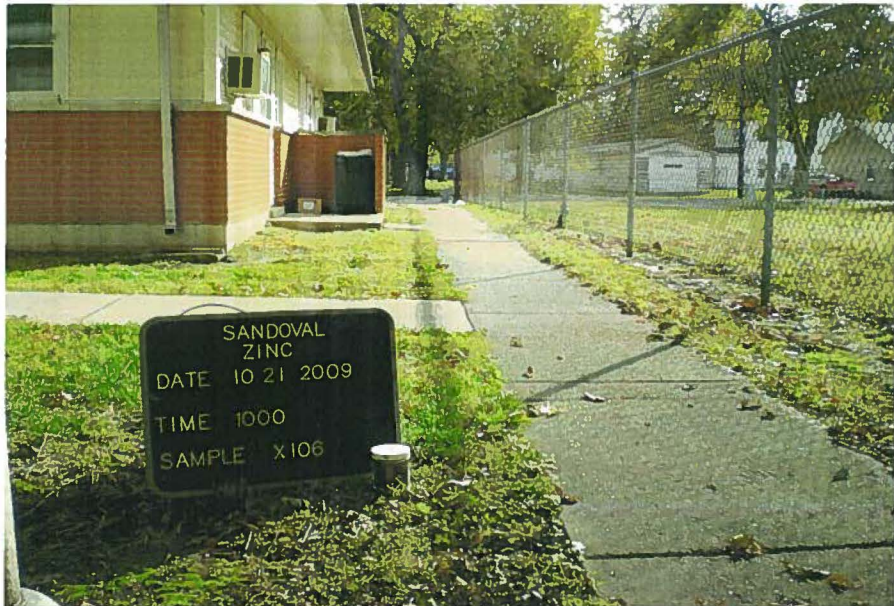
DATE:	10/21/09
TIME:	1000
PHOTO BY:	L. Range
DIRECTION:	East
COMMENTS:	<p>This location is near Perry and Broadway. X106 was collected from the southwest corner of the property. Sample consisted of a dark brown silty loam from a depth of 6 inches.</p>

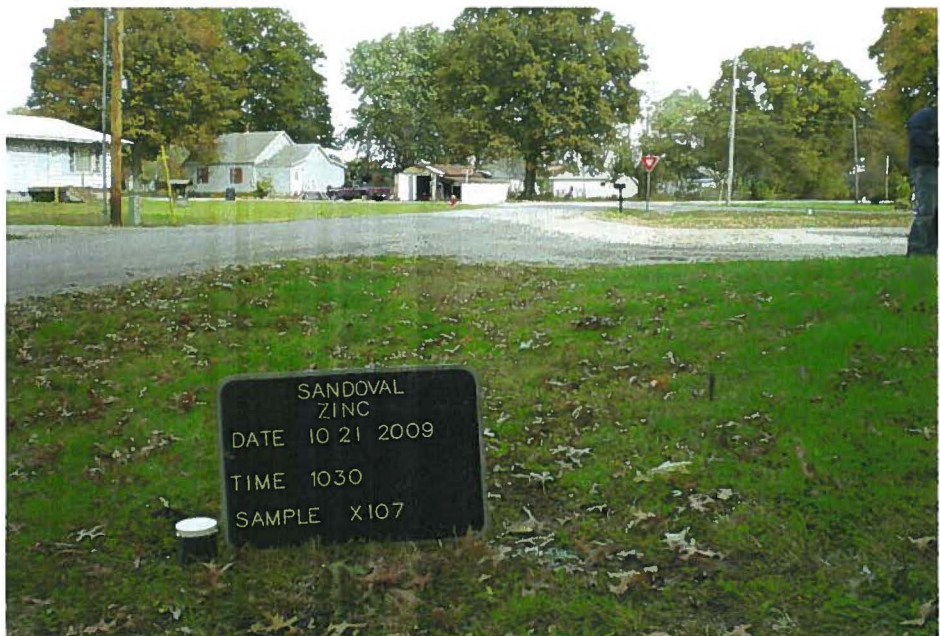
DATE:	10/21/2009
TIME:	1030
PHOTO BY:	L. Range
DIRECTION:	North
COMMENTS:	<p>This sample location was taken from the western portion of public housing near Oak Street. This sample consisted of a brown cindery mix from a depth of 6 inches.</p>

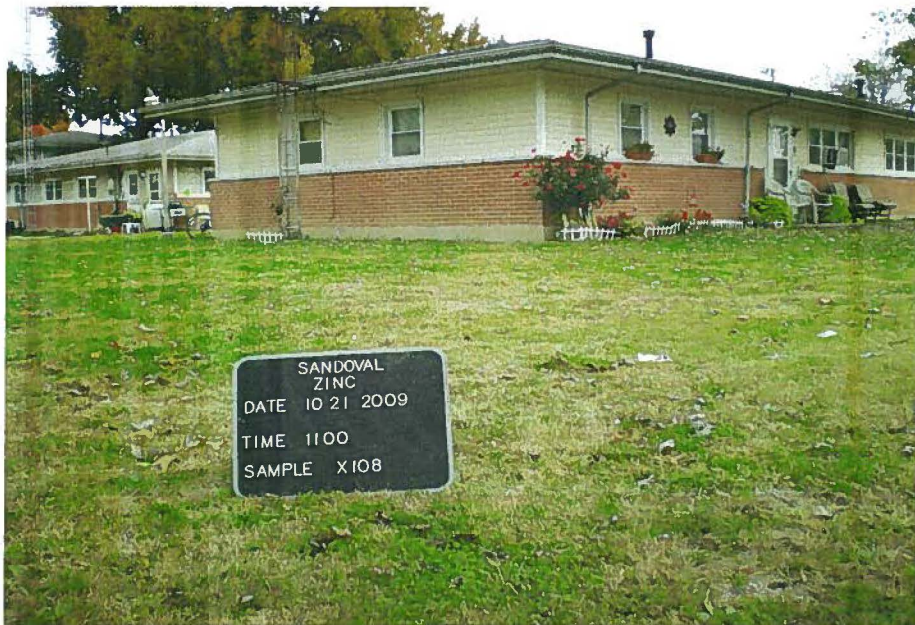
This photow was taken of Sample X108 which was located on the southwest corner of the property (Mulberry Street). X108 was collected from a depth of 6 inches from a brown cindery loam.

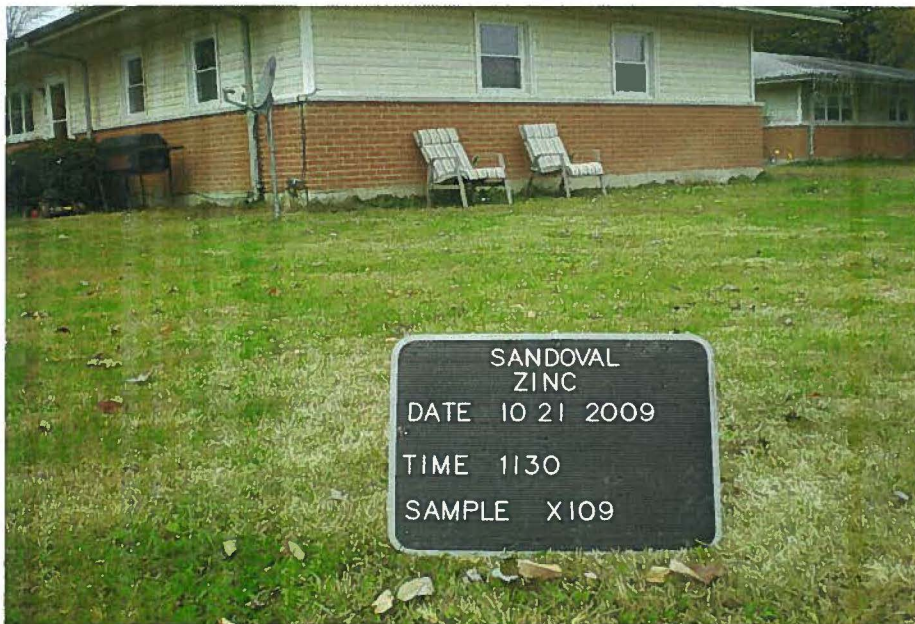
This sample was located on the northeast corner of the public housing located on Mulberry Street. X109 was collected from a depth of 6 inches from a light brown silty loam.

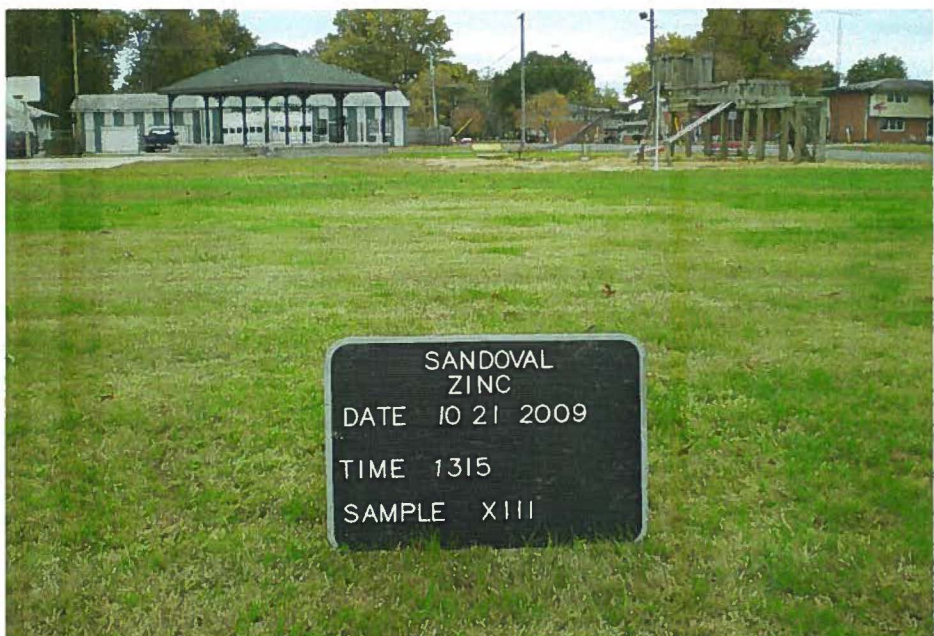
DATE:	10/21/2009
TIME:	1315
PHOTO BY:	L. Range
DIRECTION:	South
COMMENTS:	Photo was taken of sample X111. This sample was collected from the public park. X111 consisted of a brown silty loam from a depth of 4 to 6 inches.
